JEMIMA'S NEW KEEL GUIDES.

When Colin Haines found bits of plastic inside the keel lifting mechanism, he knew he had a problem.

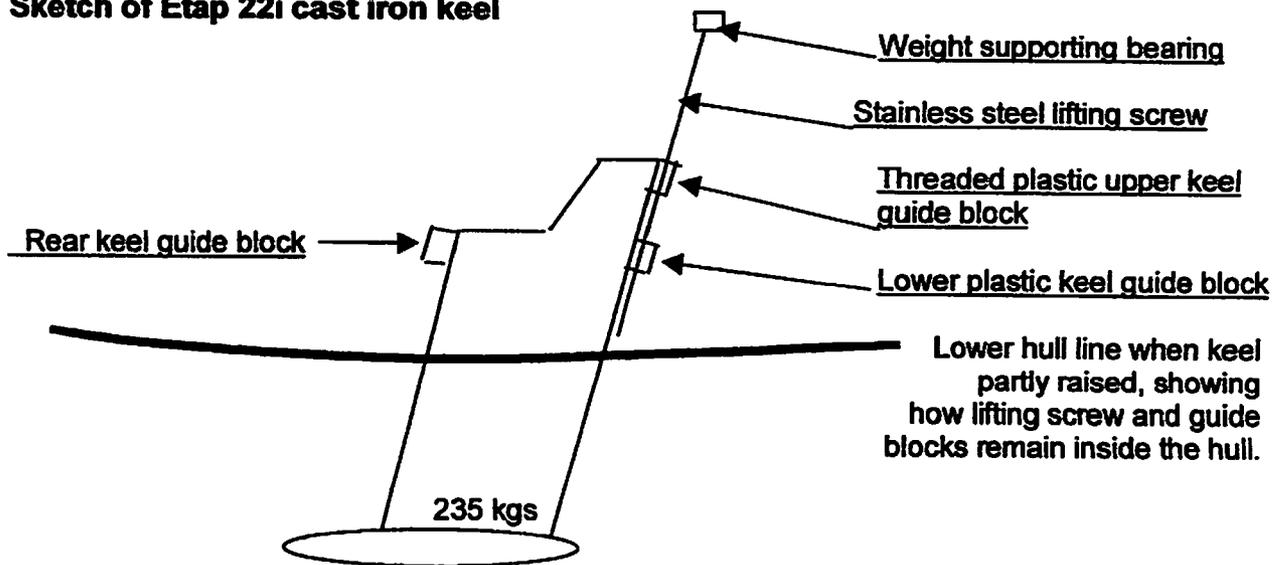
Sketch of Etap 22i cast iron keel

The drawing shows that there are two blocks of plastic bolted to the front of the keel, and one at the back, with the bottom of the latter's guide being blanked off, so that the keel can never fall out of the bottom of the hull. This block can only be removed when the keel is fully raised, as the two holes in the keel case are provided for a socket wrench to line up with the block's retaining bolts. Or put more accurately, they did all line up when we first bought Jemima, but were nowhere near lining up when I un-zipped the neat padded plastic 'leather cloth' covering of the keel case. It required the services of a jack and baulks of timber under the keel to 'persuade' the bolt heads to come back into view properly. It confirmed that something was going amiss inside the keel case, and that for the first time, we would have to spend real money on the boat to investigate the cause.
